Manhole Inspection Summary

Manhole # S61K__001MH

Insp Date: **12/29/08 10:20 AM**

Location Address: **823 s.ponca st**

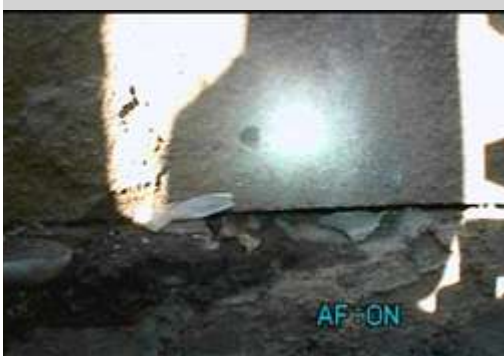
Defect 3

Condition: ☐ Sound ☐ Cracked ☐ Root Intrusion ☒ Loose Brick ☒ Deteriorated

chimney loose bricks deteriorated at frame joint

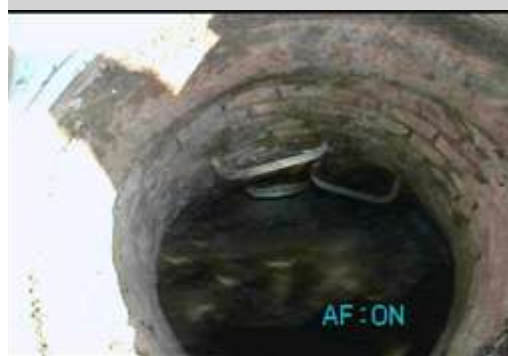
Defect 2

Steps Count: **3** Missing: **0** ☒ Corroded

steps

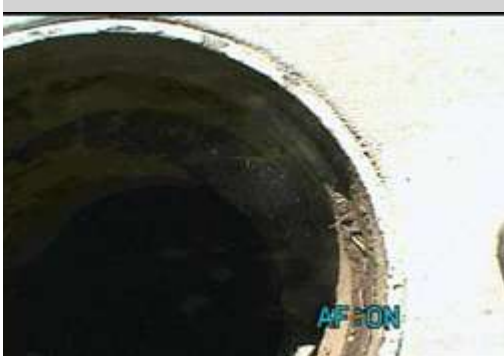
Defect 1

Frame Offset: **3.5** (in.) Condition: ☒ Sound ☐ Cracked ☐ Leaks

frame offset 3.5 inches

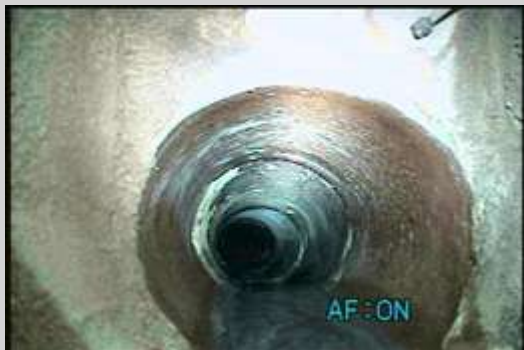
12 O'Clock Outflow

8 in. Circular Gravity Sewer
Pipe Out @ 12 O'Clock

Pipe Material: **Clay** ☒ Pipe Lined

Invert Depth: **7.66** (ft.) Flow Characteristics: **Fast**

Infiltration: **None** Pipe Seal Cond: **Unknown**

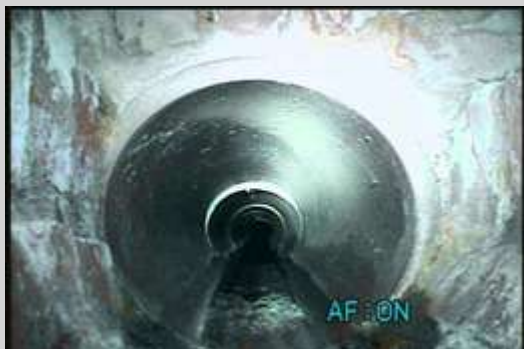
6 O'Clock Inflow

8 in. Circular Gravity Sewer
Pipe In @ 6 O'Clock

Pipe Material: **Clay** ☒ Pipe Lined

Invert Depth: **7.58** (ft.) Flow Characteristics: **Fast**

Infiltration: **None** Pipe Seal Cond: **Unknown**
